JAR-856-2387  
8 April 1968  
Page 1

Subject: Report on Visit [ ] 28 March 1968 - DC-TM-1504

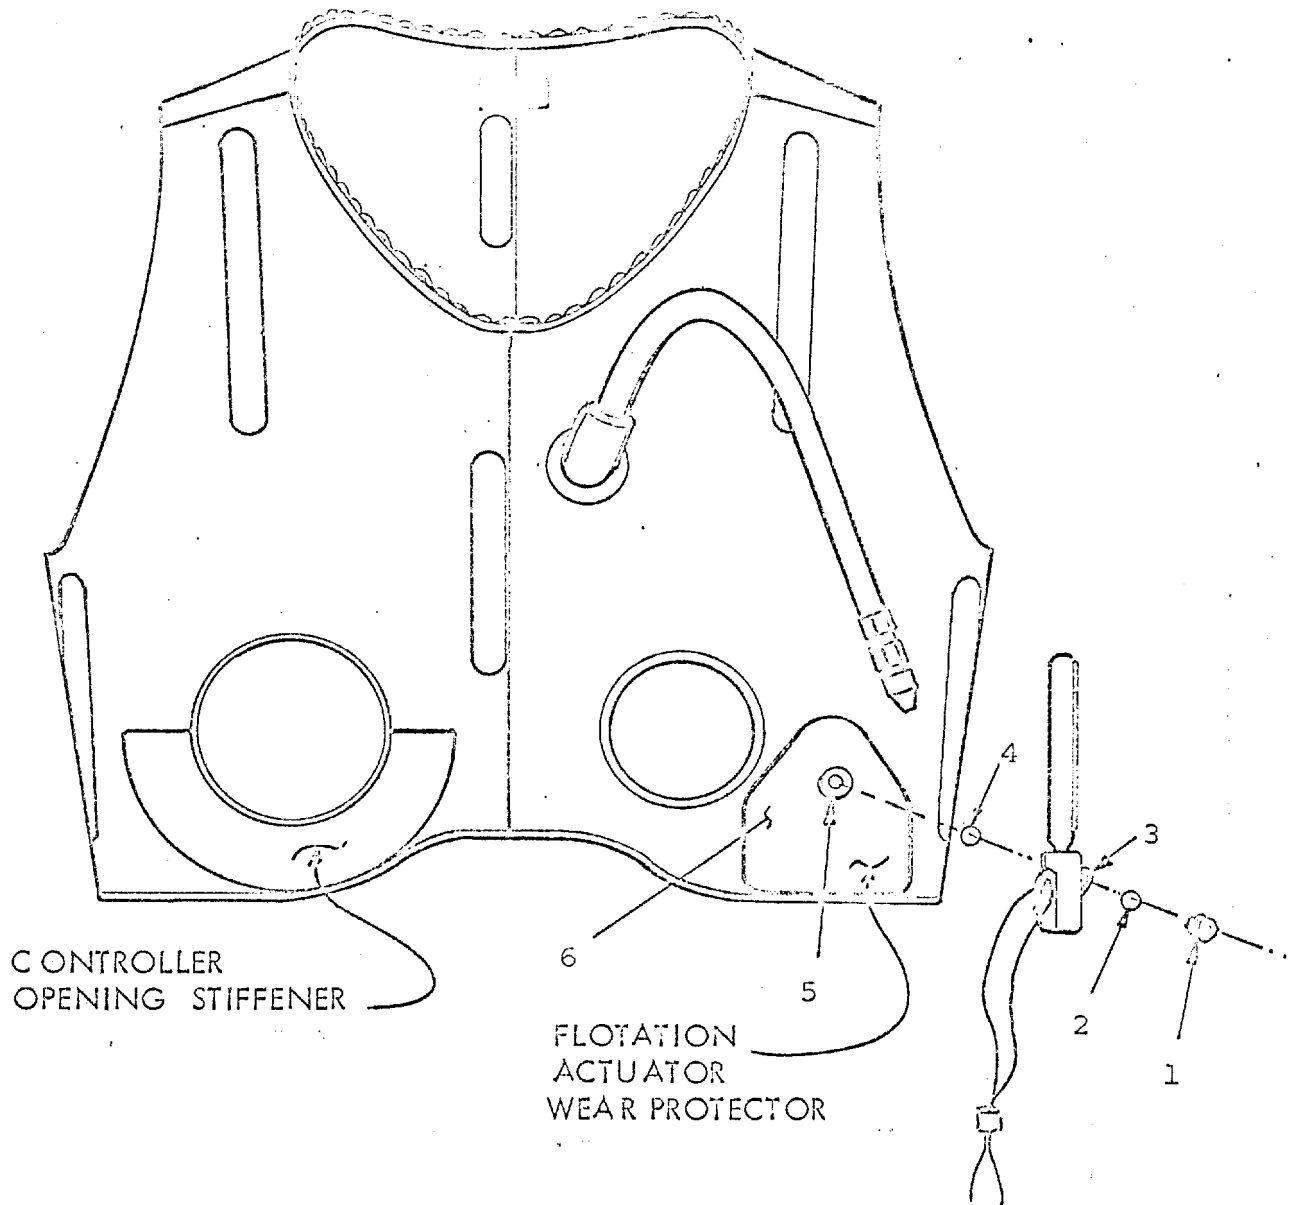
FLOTATION GARMENT ASSEMBLY  
FIGURE 1

- 4.1 Place the (white) gasket (Reference 4) over the Inflator Stem (Reference 5).
- 4.2 Place the Inflator Valve Assembly (Reference 5) over the Inflator Stem.
- 4.3 Place the (black) gasket (Reference 2) over the Inflator stem, insuring proper seating of the gasket on the Inflator Valve.
- 4.4 Screw the Inflator Cap onto the Inflator Stem and tighten securely, using an open end wrench.
- 4.5 Perform periodic inspection and test (according to GN-HM-370) before returning the flotation garment to operational status.

(Reference Figure 1)
